## ASSESSING THE OPPORTUNITIES FOR ADAPTIVE REUSE AND TOURISM DEVELOPMENT OF COURTYARD HOUSES WITHIN THE TEMPLE PRECINCT OF KAVLEM, GOA

This study aims to evaluate the structural conditions, social perspectives, and adaptive reuse potential of two historic courtyard houses in Kavlem, Goa. The study adopts a mixed-methods approach, combining spatial documentation, stakeholder interviews, people's perceptual surveys, and expert consultations with structural engineers. On-site audits, plan analysis, and photographic documentation were used to analyze two case houses: Dubashi and Gaitonde. A reuse-readiness matrix was created, and intervention techniques were suggested based on condition, cultural alignment, and community feedback. Among the two century-old courtyard houses, the structurally sound Dubashi house is deemed suitable for limited cultural use after minor repairs as per all the surveyed architects and engineers. All interviewed respondents indicate that traditional Goan courtyard houses can be adapted with minimal intervention if done sensitively. In comparison, the more fragile Gaitonde home requires considerable structural restoration before usage, with 75% of specialists

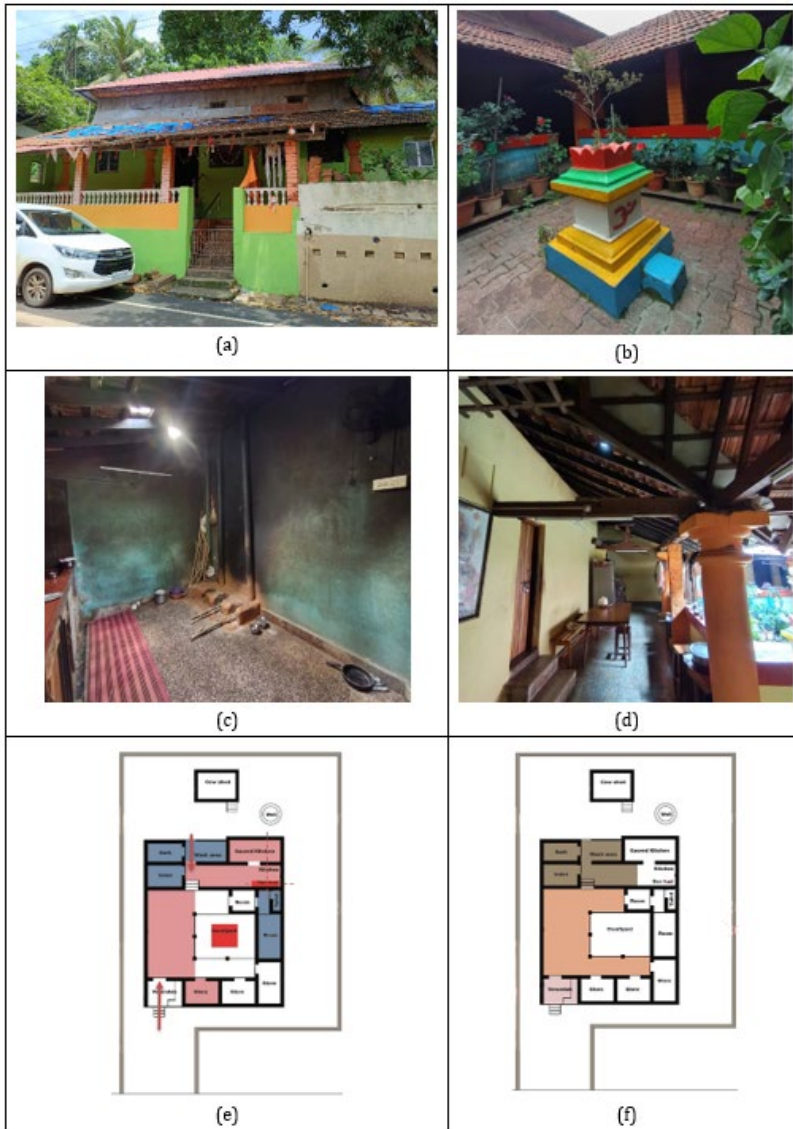
**Figure 2**

The Dubashi House, covering 220.45 sq. m, is a single-storied, rectangular Brahmin priest residence designed around a central courtyard that supports both spatial circulation and climatic comfort. The layout consists of private sleeping chambers, a Devkud (prayer room), storerooms, baths, traditional service zones, and a front verandah. Its spaciousness and the existence of unused spaces make it an excellent option for adaptive reuse, supporting both daily functions and ceremonial programs. Constructed with load-bearing laterite masonry and finished with lime or cement plaster, the house features a Mangalore tile roof over timber rafters and purlins, with floors of red oxide or stone slabs-some now covered with matting. Timber columns/traditional framing support the house structurally. Mossy dirt/stone/tile are used to create a courtyard area. Signs of fatigue are found throughout this home; rot and moisture damage on timber roof areas (chiefly kitchen) and external PVC pipe drainage systems are not original to the structure. Organic overgrowth and signs of neglect are particularly visible around service areas.

**Figure 2 Views of the Dubashi House (a) Front Elevational View; (b) View of the Central Courtyard; (c) VIEW of the Kitchen; (d) Entrance View of Foyer and Prayer Room; (e) Defensible Spaces Concerning Sacrality; (f) The Pathways and the Boundaries.**

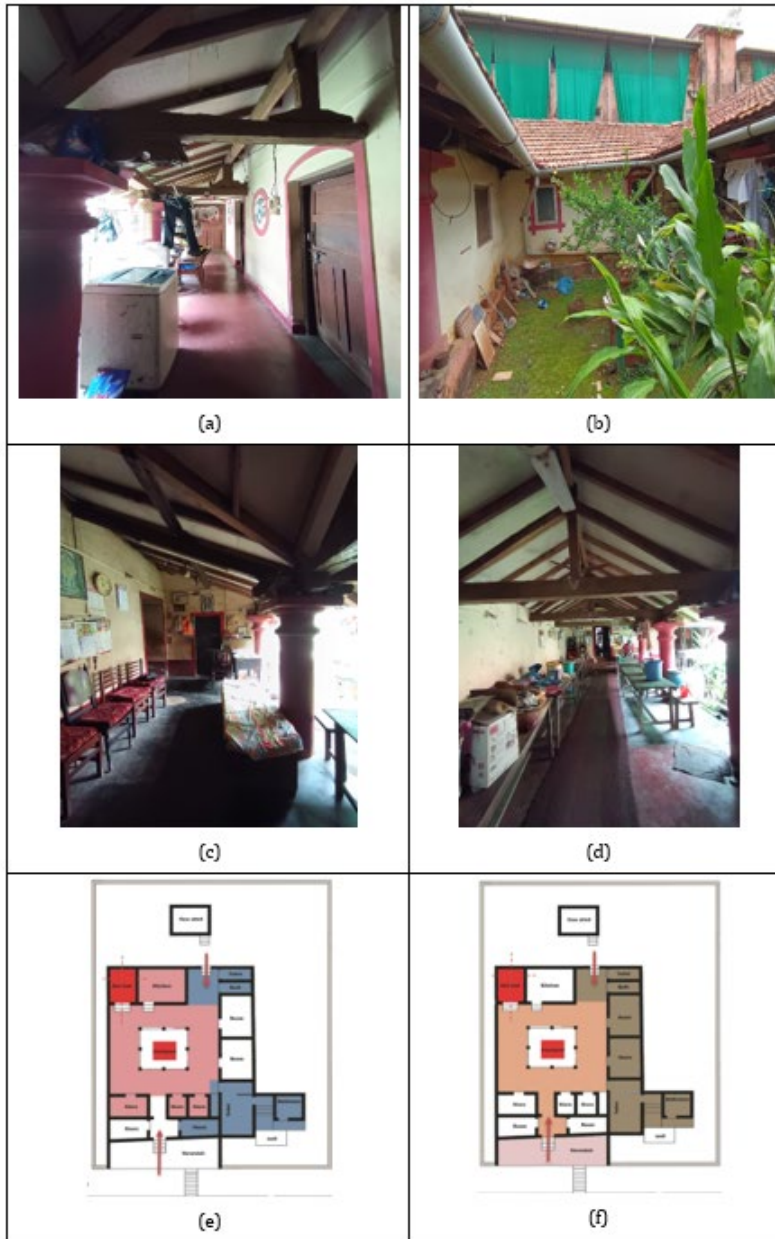
**Figure 3**

The Gaitonde House is a single-story (178 m<sup>2</sup>), rectangular Brahmin priest residence constructed of load-bearing laterite block walls. The house consists of a central courtyard, a Devkud (place of worship), two kitchens (one for worship and one for food storage), eight bedrooms, three bathrooms, and laundry areas. The house is zoned spatially with a high degree of complexity for use of rituals and general household activities to be performed within a limited amount of area. The house materials show signs of deterioration due to regular wear and tear. Structurally, the timber rafters supporting the Mangalore tile roof are showing deterioration and sign of leaking; red oxide concrete floors have been patched with either vinyl or tiled surface coverings; the walkways and courtyard have been constructed out of terracotta tiles or compacted earth. The soot-laden and lack of adequate ventilation of the sacred kitchen show signs of rotting timber, deterioration of plaster and significant cracking of the ceiling, and lots of neglected areas containing moss, debris, overgrown vegetation, and clogged drainage. The outer structures (gates and boundary walls) are showing signs of rust and excessive overgrowth.

**Figure 3 Views of the Gaitonde House (a) Utility Area View; (b) View of the Central Courtyard; (c) View of the Entrance Foyer; (d) Entrance View of Public Dining Area; (e) Defensible Spaces Concerning Sacrality; (f) The Pathways and the Boundaries.**
